NEW HAMPSHIRE DOT STORM PIPE REHABILITATION USING GEOPOLYMER LINING SYSTEM

- New Hampshire DOT – Culvert Slipline Rehabilitation NH-114 Over Bowman Brook

Structural Rehabilitation of Corrugated Metal Storm Pipe Using QLS Spin-Cast GeoKrete Pipe Lining System

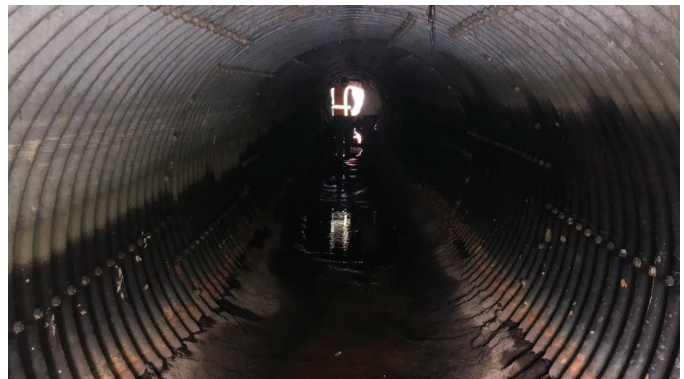
A CMP storm culvert, installed by the New Hampshire DOT decades ago, had seen better days. Due to its age, the structural integrity of a 210 LF of 90" corrugated metal storm pipe had been compromised. There was so much corrosion, the invert had completely degraded and was missing; causing the culvert pipe to depress and take on more of an elliptical shape from the original 90" round shape. Complicating the issue was the discovery of missing pipe sections... again due to years of use and corrosion build-up over time. Left unrepaired, the roadway above would begin to sink and potentially lead to a collapse of the pipe and roadway.

Compromised 90" Corrugated Metal Pipe

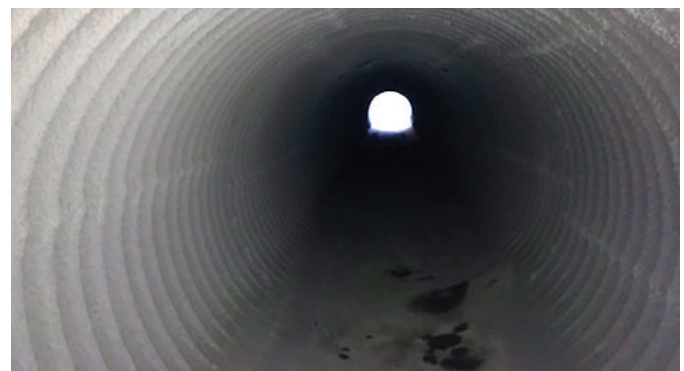
CMP Restored Using The Quadex Lining System

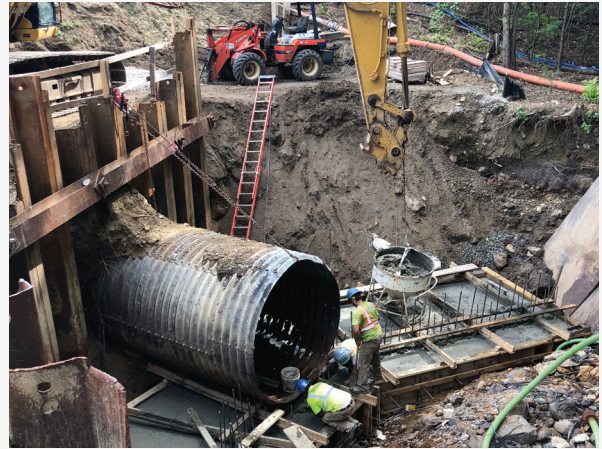
NHDOT culvert required significant reinforcement as part of the entire rehab process.

On this project, a bypass system was required to divert the brook and stormwater flow. Once operational, the culvert was cleaned, debris was removed and extensive invert repairs were made. In addition, the portions of missing pipe (at 3 o'clock and 9 o'clock) were also repaired. Typically a reinforcing mesh or grate, combined with hand-troweled GeoKrete®, fill these voids prior to the pipe relining. Once done, GeoKrete was precision spin-cast to a 2" thickness design. The completed project met all objectives and requirements set prior to repair and was the first approved and completed GeoKrete geopolymer lining installation with the New Hampshire Department of Transportation.

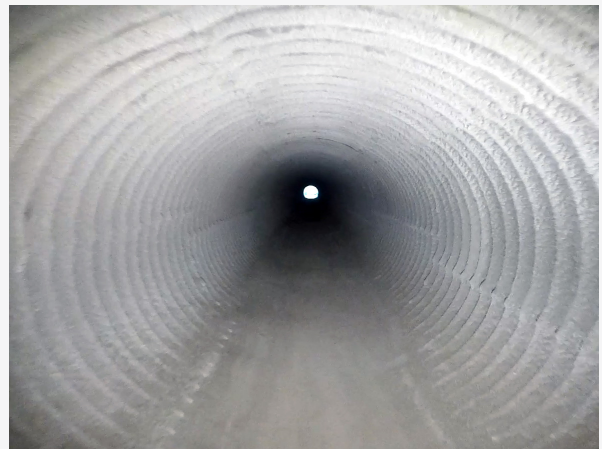
Post installation inspection of the GeoKrete lined culvert shows precision and cleanliness of the application.

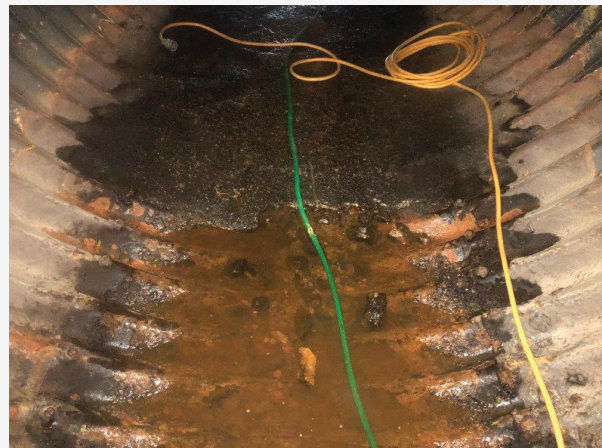
Previous attempts to reline the corroded invert had failed.
